# **Harbour Baseline Study:**

## **Lower Whanganui River Management Strategy**

A report prepared for the Wanganui District Council

Client Report 2016-06 CRep\_Prfl

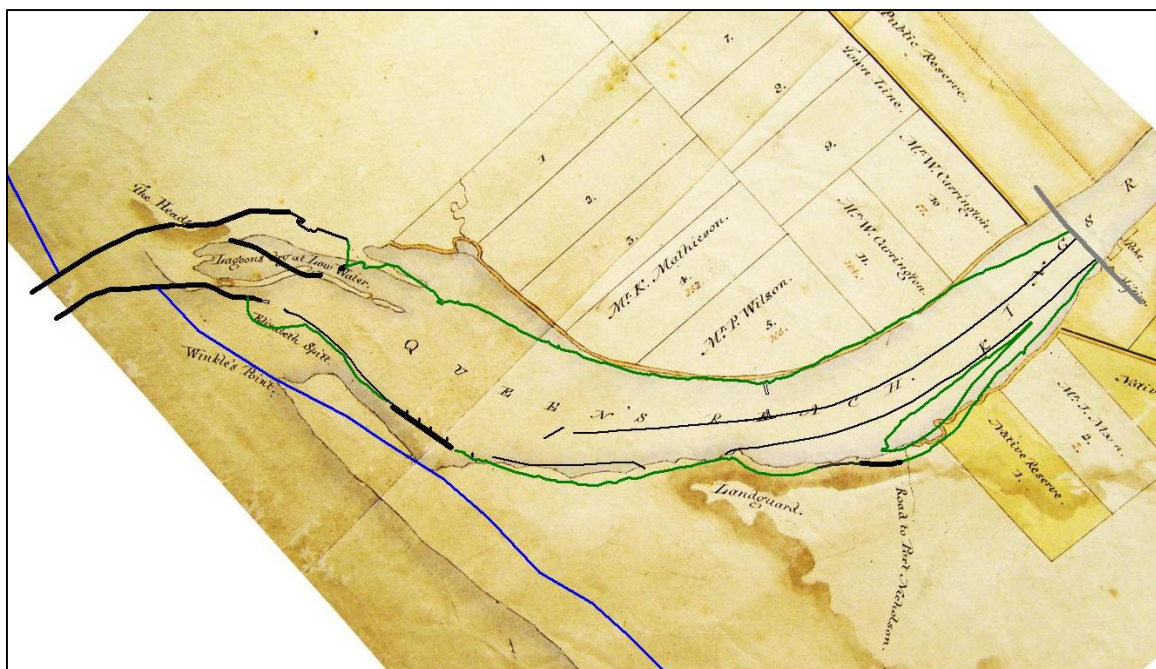
**Figure 1** The NZ Company 1842 Land Settlement Plan is the earliest detailed map of the lower Wanganui River including South Spit and coastline. Marked are: the Cobham Bridge in grey, the 2013 riverbanks in green, the 2015 structures in black, and the 2013 coastline in blue.

The earliest use of the river for colonial navigation is described in, for example, King (1964) with the earliest comprehensive map being the New Zealand Company's Land Settlement Plan of 1842. This map is reproduced as Figure 1 and has had the modern shorelines, port and navigation structures superimposed for comparison. There are several points of note on this earliest map including no Corrlis Island (in Figure 1 the green outline locates the present feature), the large reclamation immediately upstream of the present Port, a shortened South Spit, a very wide rivermouth, and a North Spit with ribbon-like sand bars extending upstream for several hundred metres. This coastal morphology indicates a time of very high littoral sediment supply so likely entrance shoaling and frequent channel changes would be inevitable, making navigation hazardous and challenging, as confirmed by the 1846 Cook's Strait Almanac (King, 1964, p1).

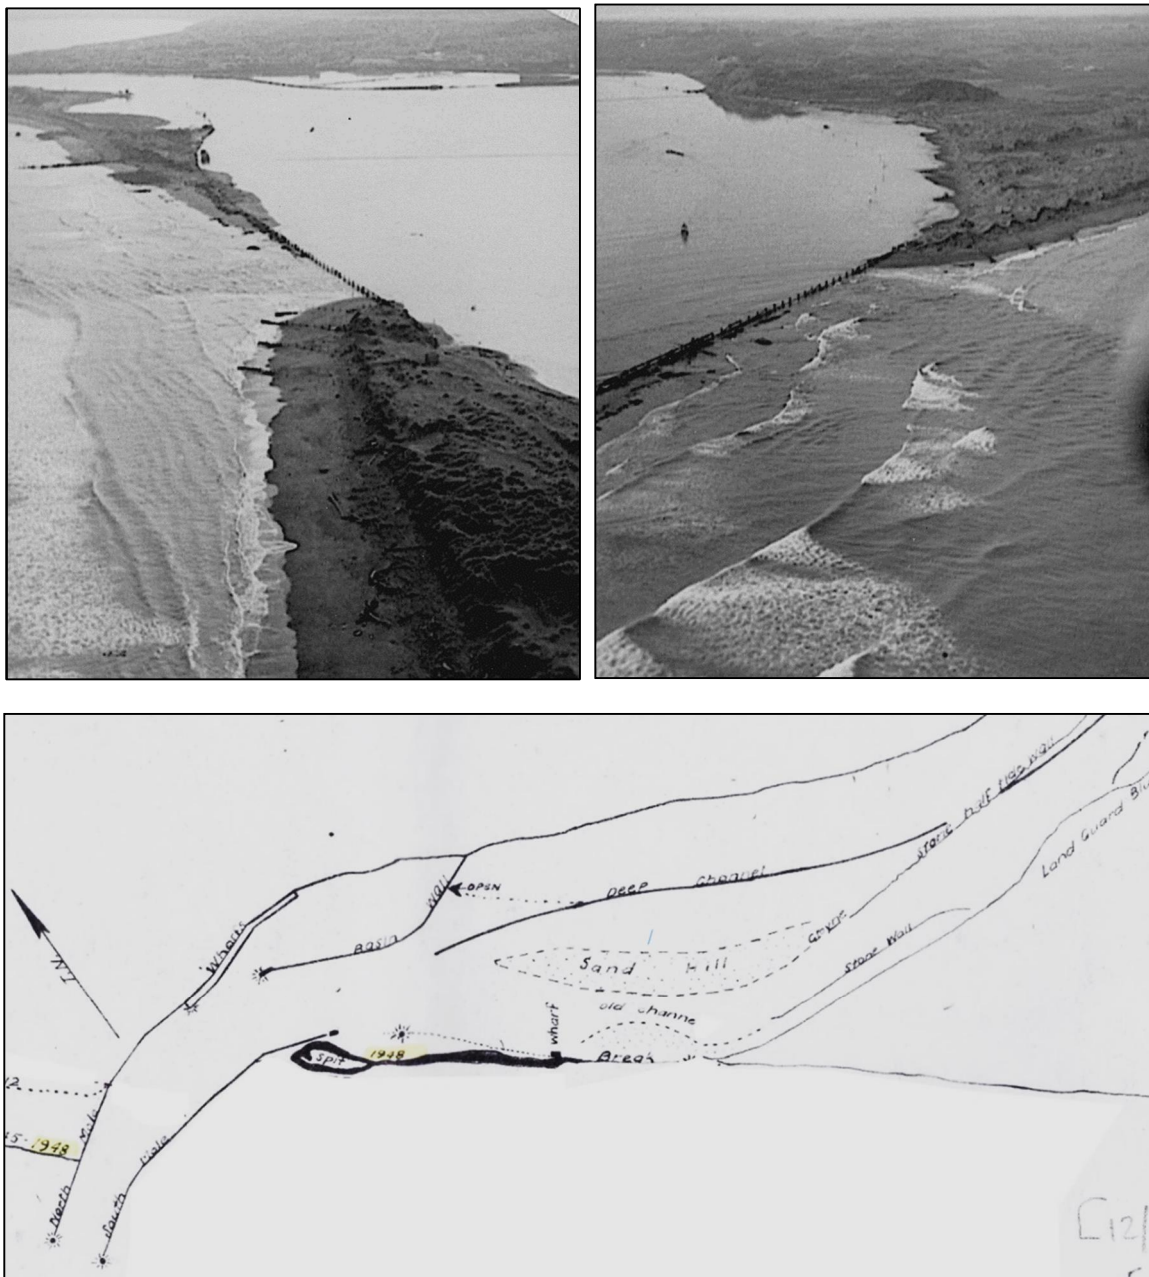
**Figure 9** South Spit Breach on 5-7-1947 (upper photos) taken at high/ebbing tide and as sketched by Harbour Board staff in 1948 (lower) with surrounding morphological features referred to in the text having been marked.

By the end of 1946 the situation had worsened and the Public Works Department (PWD) offered assistance. Renewed breaching occurred in July 1947 (Figure 9 shows aerial views at high tide) with overwash sand creating a delta which crossed the navigation lead line in the Main Channel. It is noted that the late 1940s was a period of relentless storms and high seas, likely an El Nino event. In January 1948, the PWD had taken over work closing the breach by constructing a continuous wall using 3 to 5 ton blocks of concrete. By May 1948 the navigation channel had reduced to “gutter” and a large dome-shaped shoal (described by the Harbour Master as an “island”, and by the Supervisor as a “sand hill”) had formed opposite the breach. River flow was carrying littoral overwash sand as far as the Basin. Shipping to town was now via a new landward channel (the Balgownie or North Channel) around the landward side of the “island” which is henceforth referred to as the *Dome Shoal or Dome*.

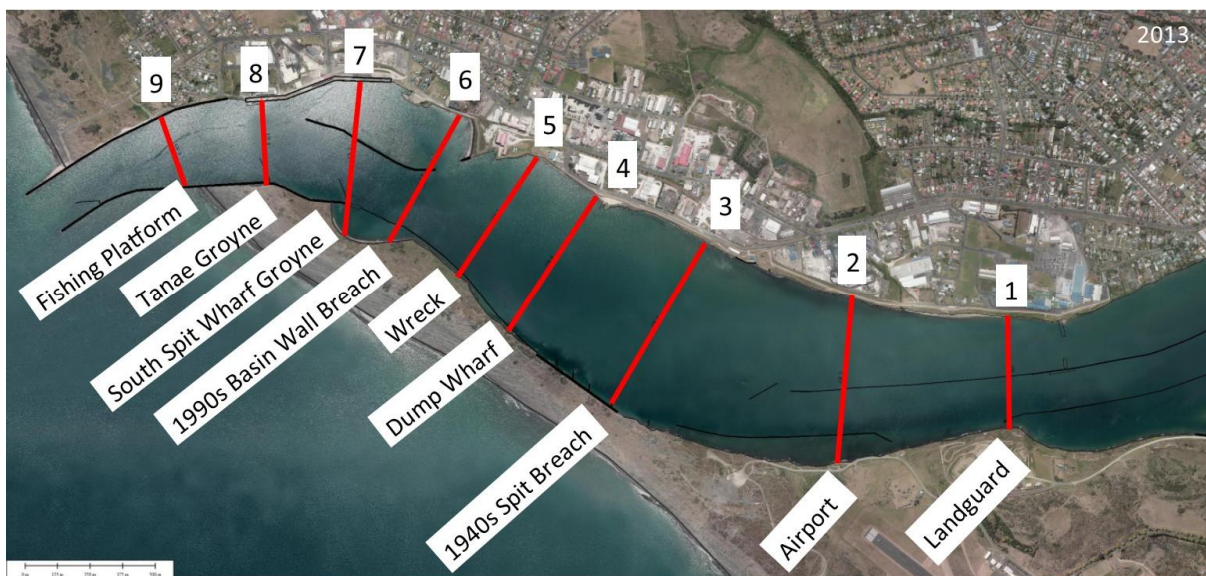
**Figure 15** Section locations (red lines), numbers and names superimposed upon a 2013 aerial photograph. Black lines locate river control structures.

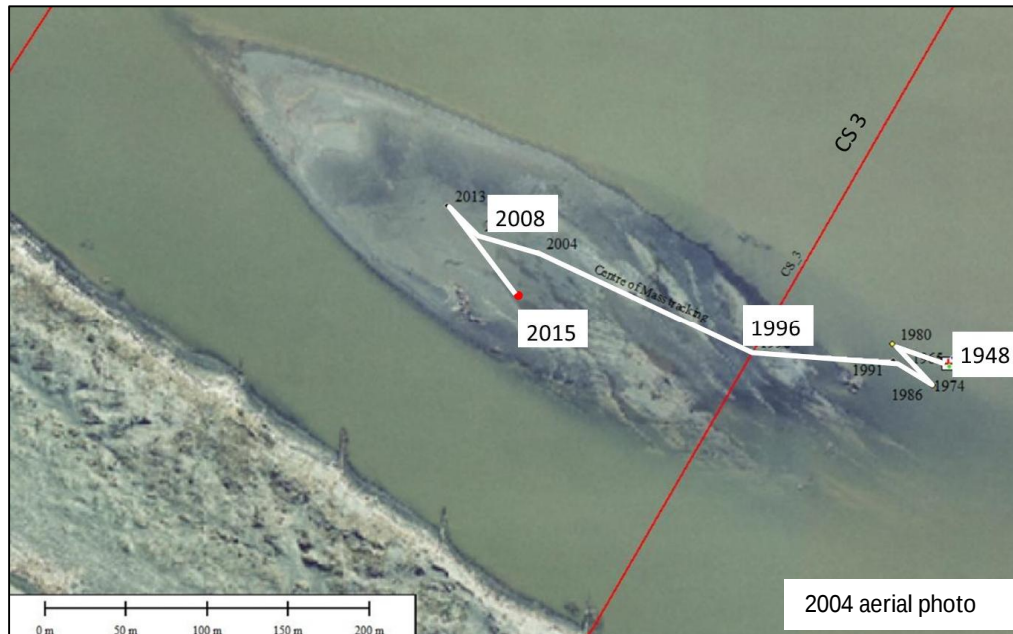
**Figure 18** Migration tracking of the Dome-Shoal based on aerial photo centres of mass between 1948 and 2015 superimposed upon the 2004 aerial photograph

The Dome's most recent upstream-directed centre of mass relocation appears to reflect change in the wider sediment transport regime (rather than depicting a change in net sediment transport direction), and while this change may be ongoing/systematic, it may alternatively have been triggered by the June 2015 flood. It is noted that while the flood caused significant flooding upstream of the Cobbam Bridge, it was relatively insignificant in the Estuary due to coastal control parameter values, e.g. neap tide range. However, sustained moderate events are capable of driving significant morphological change in coastal settings.

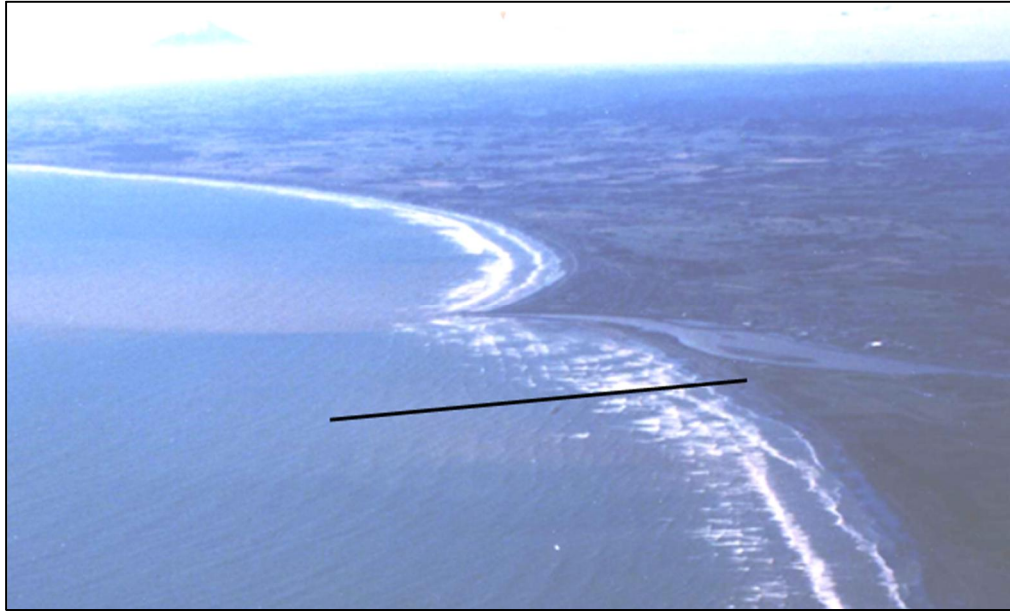
**Figure 24** Wanganui coast (1993) with marine outfall (approximately) located. Linear bars and troughs (2D morphology) are evident on the far side of the rivermouth (Castlecliff coast). Two-dimensionality is also evident in bottom of photo (beyond 4 km from rivermouth), with transverse (three-dimensional) morphology from the rivermouth to beyond the marine outfall.

with increasing distance southward of the rivermouth and pre-1980 aerial photos show the change to linear form occurred from about 2 km. However, the 1800 m long marine outfall constructed in the early 1980s some 3 km south of the rivermouth, has had a significant effect upon nearshore processes (Shand et al., 2005) such that 3D morphology now extends some 4km south of the rivermouth (see Figure 24).
